**DESIGN, CONSTRUCTION AND  
PERFORMANCE MONITORING OF  
COVER SYSTEMS FOR WASTE ROCK  
AND TAILINGS**

**VOLUME 5 – CASE STUDIES**

**MEND 2.21.4e**

OKC Report No. 702-01

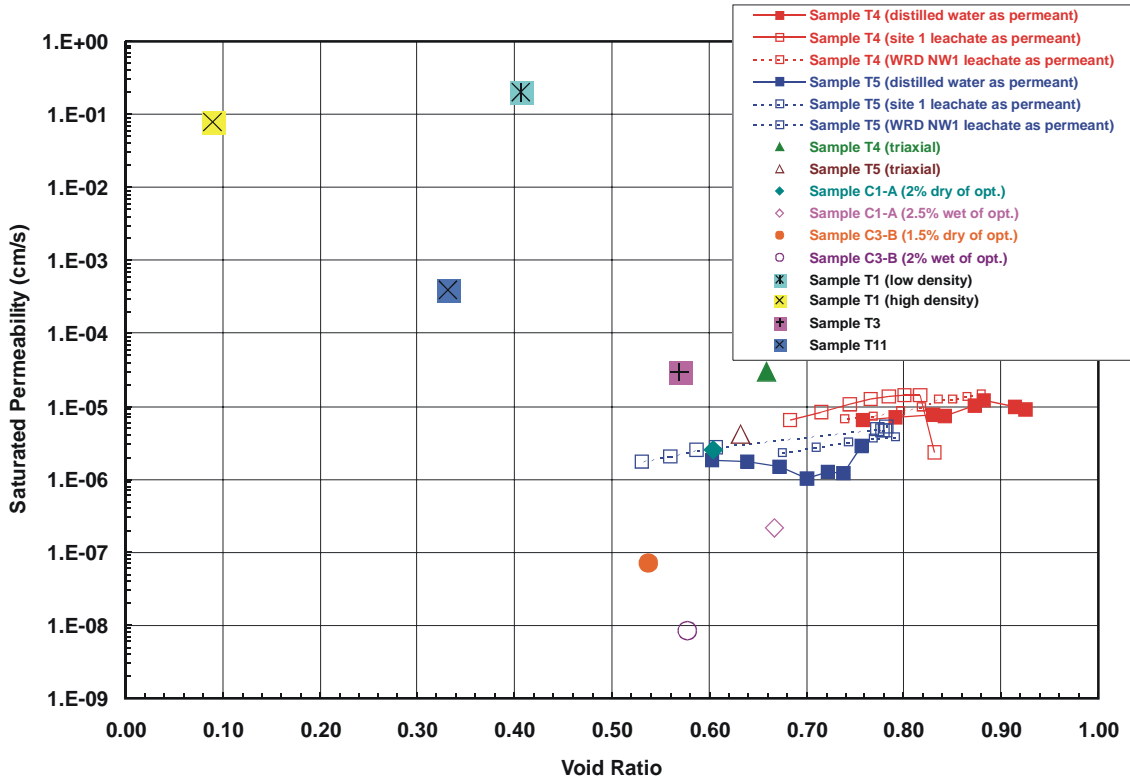
**Figure 1.1** Hydraulic conductivity laboratory data for the seasonally humid site.

$1 \times 10^{-6}$  cm/s, while the smectitic clay was measured at between one and one-half to two orders of magnitude lower for the same conditions. Figures 1.1 and 1.2 show the hydraulic conductivity and SWCCs for the waste and cover materials.

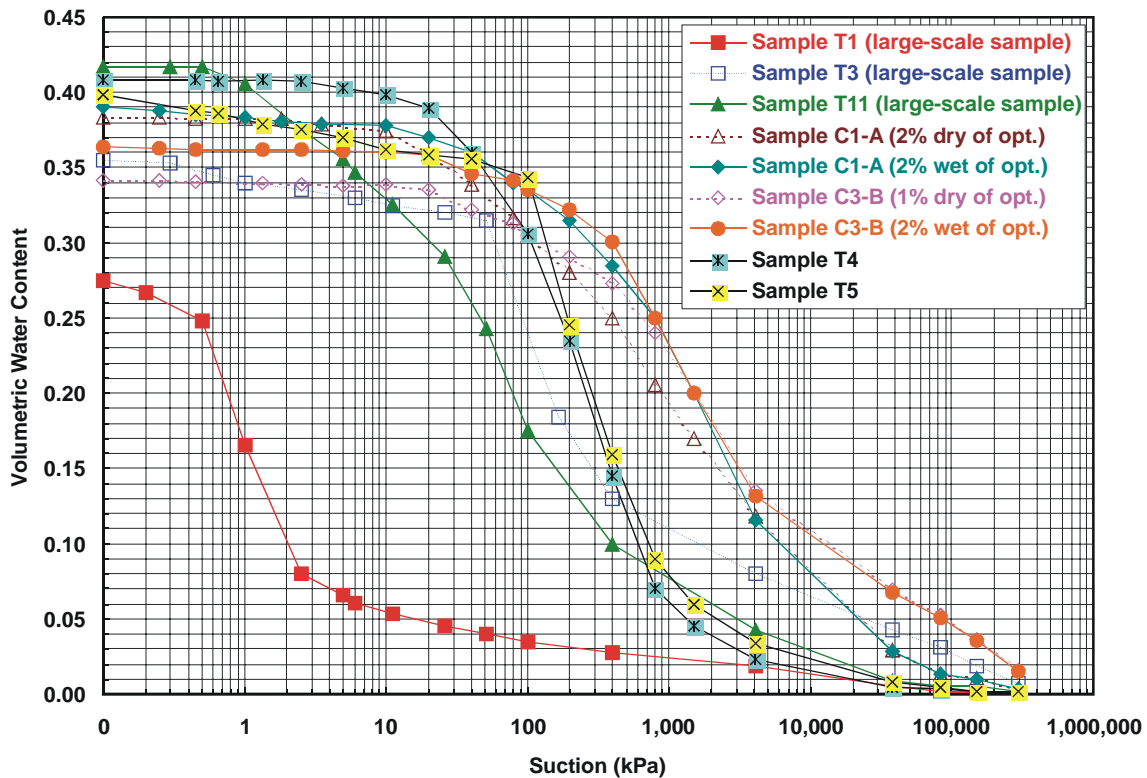
**Figure 1.2** Soil water characteristic curve laboratory data for the seasonally humid site.

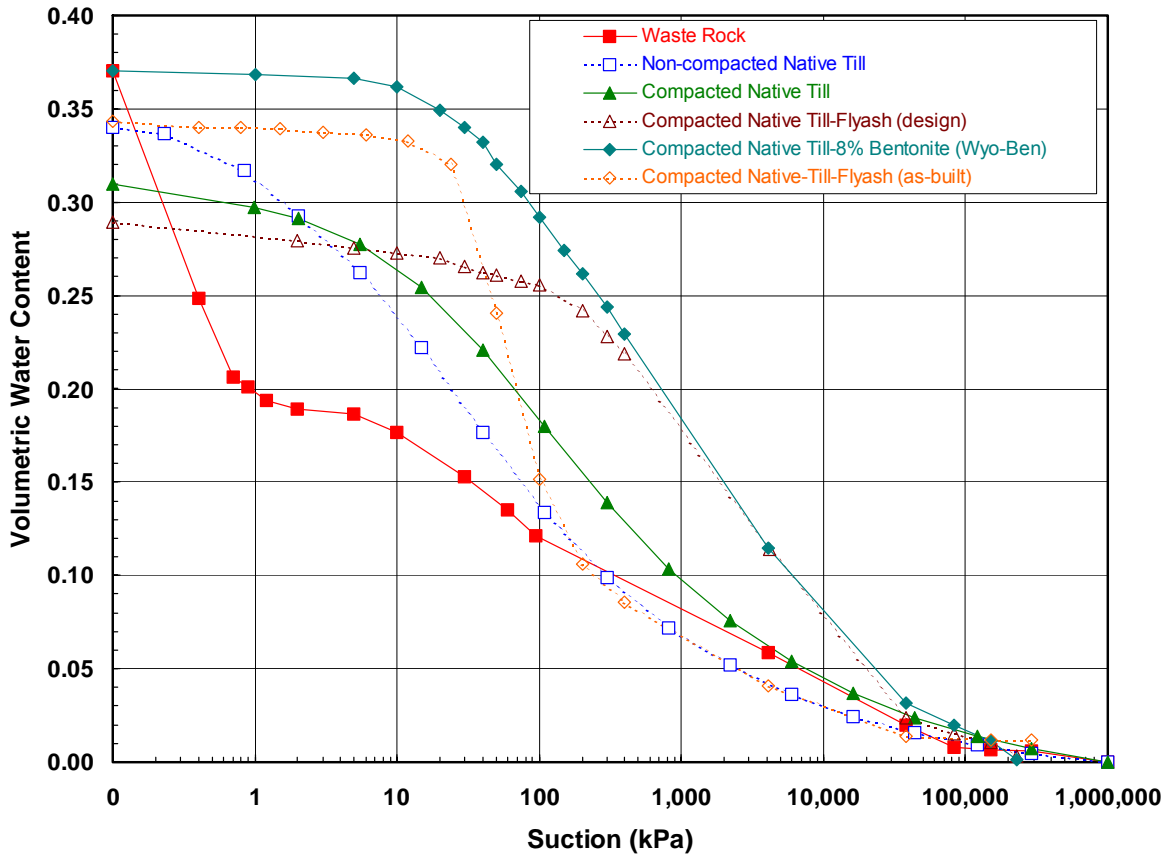
Figure 1.3 Soil water characteristic curve of the run-of-mine cover material for Myra Falls.

The air entry value increased to approximately 10 kPa as a result of compaction and the porosity decreased from 0.34 to 0.31, although the slope of the SWCC was similar. The small percentage of fine textured material within the till sample, and as a result the non-plastic behaviour of the till, led to the relatively small increase in the air entry value following compaction. The SWCC of the waste rock is bi-modal as a result of the presence of coarse material as well silty material “created” by physical, chemical, and biological weathering of the waste rock. The waste rock is gap graded with two distinct air entry values, as shown in Figure 1.3. The first occurring at a suction near zero and the second at approximately 7 kPa.

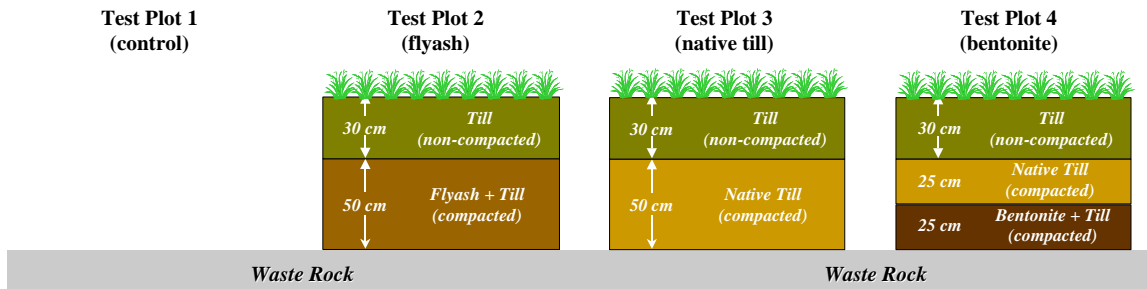
Figure 1.4 shows the physical layout and materials of each test plot, which were constructed based on the modelling results. Test Plot No.1 (TP-1) is a control test plot with a bare waste rock surface. All three of the remaining test plots were constructed in a similar manner. That is, each test plot had approximately 50 cm of compacted material placed directly on the waste rock platform surface, overlain with 30 cm of non-compacted native till. A seed mix of grasses and legumes applied to the three test plots.

Figure 1.4 Test plot configuration for Myra Falls.

Test Plot No.2 (TP-2) and Test Plot No.3 (TP-3) were constructed with two 25 cm lifts of compacted material. The TP-2 compacted layer consisted of a mixture of flyash and native till. The flyash was added to the native till on a 25% mass basis. The flyash was dry mixed with the native till using a pulvi-mixer. The flyash-till mixture was moisture conditioned using the pulvi-mixer, and then mixed repeatedly until consistent moisture conditions were achieved throughout the depth of the lift. Each lift was compacted using a smooth drum vibratory roller. The TP-3 compacted layer was constructed from native till only.

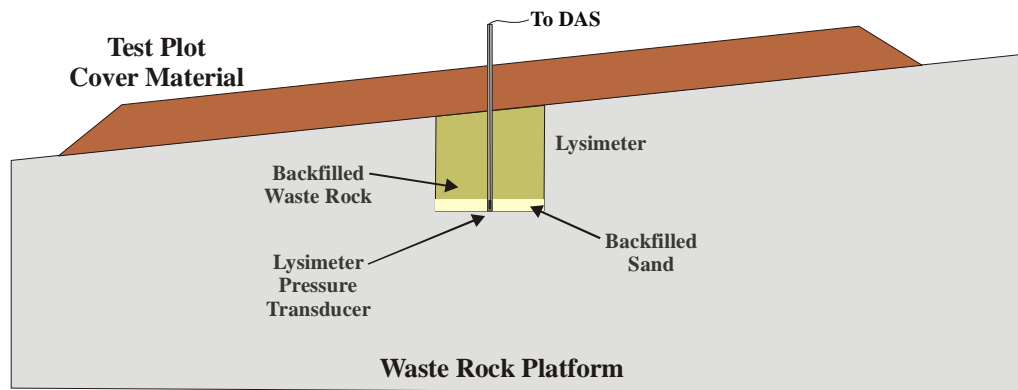
Four lysimeters were installed following completion of the waste rock test plot platform. Each lysimeter was installed using the same procedure and materials, and is shown schematically in Figure 1.5. The pressure transducer in each lysimeter is located at the base of the lysimeter inside the centrally located piezometer. The TP-1 and TP-2 lysimeter pressure transducers are connected to the TP1-TP2 data acquisition system (DAS). The pressure transducers installed in the TP-3 and TP-4 lysimeters are connected to the TP3-TP4 DAS.

**Figure 1.5** Schematic of the Myra Falls lysimeter configuration.

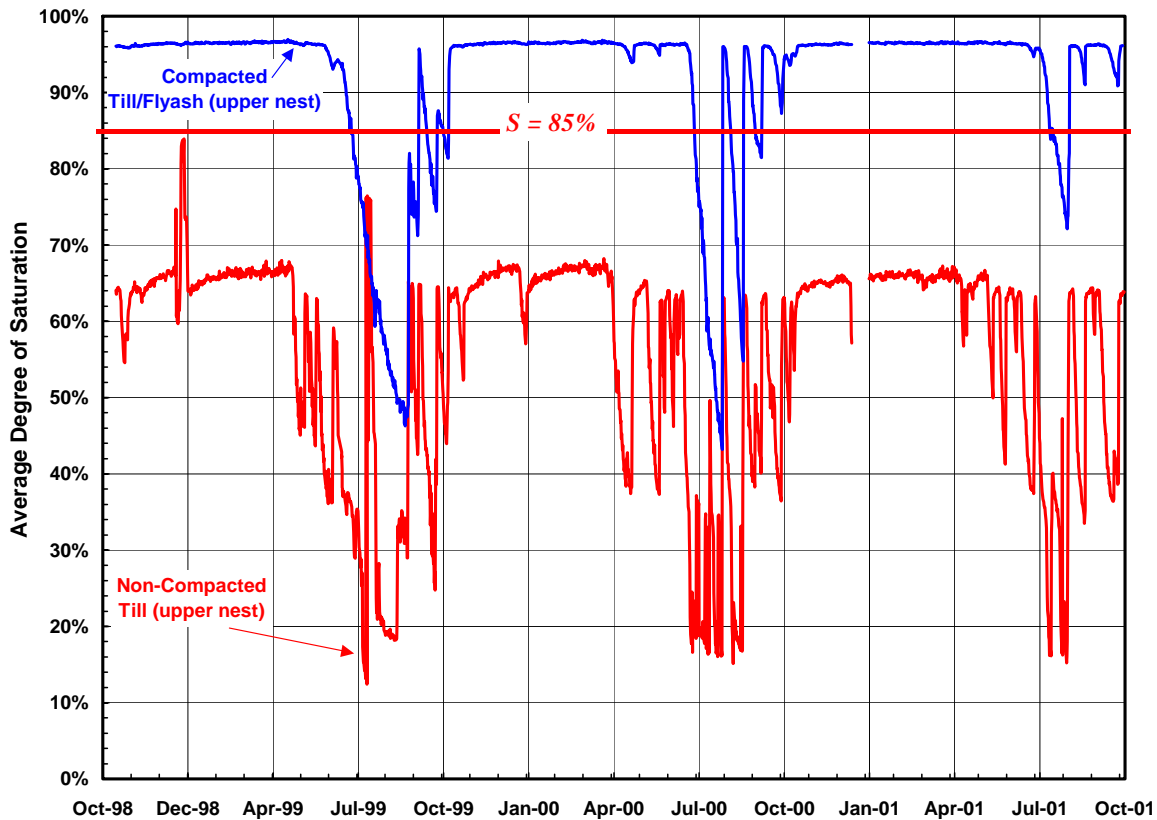
The average degree of saturation of the compacted till-flyash layer and the non-compacted layer at TP-2 is shown in Figure 1.6. The data shown in Figure 1.6 is calculated by averaging the response of the individual sensors in each layer that were installed across the thickness of the layer. For example, the average degree of saturation values calculated for the compacted till-flyash layer is based on the response of four sensors. Note that the data shown is based on the response of both the suction sensors and the volumetric water content sensors. The non-compacted material has lower moisture conditions than the compacted till-flyash layer, which is to be expected as it is exposed to the atmosphere. In addition, the response to the demand for moisture during the summer is more significant. The till-flyash compacted layer does not maintain tension saturation conditions during the hot dry summer months at the site. The average degree of saturation of the compacted till-flyash layer dropped to approximately 50% during the summers of 1999 and 2000 in response to the demand for moisture from the atmosphere. This is not a desirable performance characteristic because it implies an increase in oxygen diffusion coefficients and ultimately an increase in oxygen ingress during these hot dry periods. However, it should be noted that in each case the degree of saturation of the compacted till-flyash layer “recovers” to tension saturated conditions during wet climate conditions.

**Figure 1.6** Average degree of saturation of the compacted till-flyash and non-compacted native till at TP-2 for Myra Falls.

There are three key reasons for the performance of the compacted till-flyash layer shown in Figure 1.6, all of which contribute to the measured performance. First, the till-flyash material itself does not possess sufficient moisture retention to “oppose” the demand for moisture and thus significantly limit the reduction in moisture content. Second, the overlying non-compacted growth medium does not possess sufficient moisture storage and retention such that this layer alone satisfies all of the atmospheric demand for moisture. This simplest solution for this problem is to increase the thickness of the non-compacted layer, which would also be more consistent with rooting depths of undisturbed areas at the site. Finally, the hot dry summers that are prevalent at the site contribute to the decrease in moisture conditions of the compacted till-flyash layer. This is important to note because it is a common mistake during cover system design to assume that if there is a moisture surplus on an annual basis, then limiting oxygen ingress will be possible. However, the data shown

The performance of the compacted till-flyash layer was not as designed. The primary reason for the difference in performance between that anticipated and that measured during the past three years is illustrated in Figure 1.3. A SWCC of a compacted till-flyash sample collected after construction of the test plots is shown in Figure 1.3. The SWCC of the compacted till-flyash layer used during the design stage of the project is significantly different than that measured on the till-flyash mixture obtained during construction of the test plots. The latter material possesses significantly less ability to retain moisture as suction increases. The performance of the compacted native till layer and the non-compacted native till at TP-3 was similar to that described for TP-2, in that the demand for atmospheric moisture during the summer was satisfied by the compacted native till layer. This performance was anticipated based on the soil-atmosphere cover design modelling.

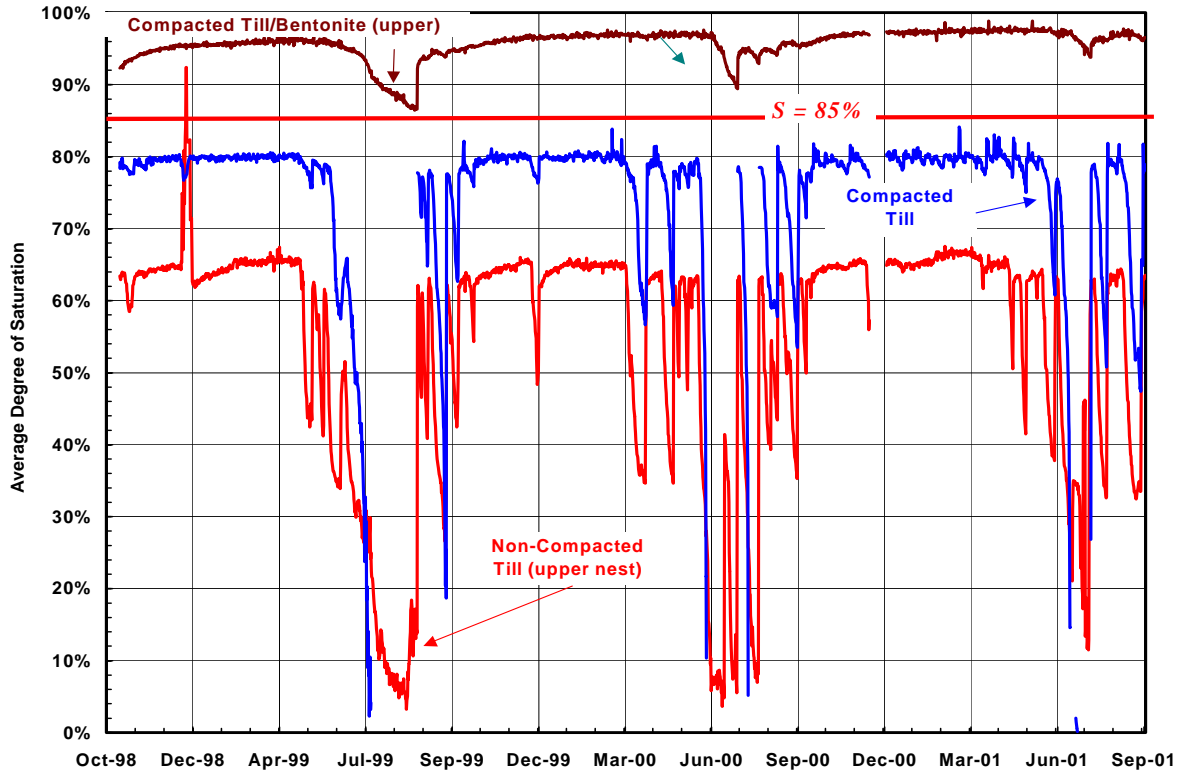
Figure 1.7 shows the average degree of saturation for the compacted till-bentonite layer, the compacted native till layer, and the non-compacted till layer at TP-4. The performance of the compacted till-bentonite layer is characteristic to that discussed earlier for the till-flyash and native till compacted layers at TP-2 and TP-3, respectively. However, the compacted till-bentonite material possesses significantly more moisture retention as suction increases (see Figure 1.3), and therefore the average degree of saturation of the compacted till-bentonite layer during the summer remains above or just below 85%. This is a positive performance results, as is the ability of this layer to “recover” and increase in moisture content in response to wet climate conditions. Figure 1.8 clearly shows that the decrease in moisture content within the compacted till-bentonite layer is a function of the demand for atmospheric moisture during the summer. The sensor installed near the upper interface of the compacted till-bentonite layer decreases in moisture content during the summer, while the sensor at the base of the layer maintains tension saturated conditions throughout the summer.

**Figure 1.7** Average degree of saturation of the compacted till-bentonite and non-compacted native till at TP-4 for Myra Falls.

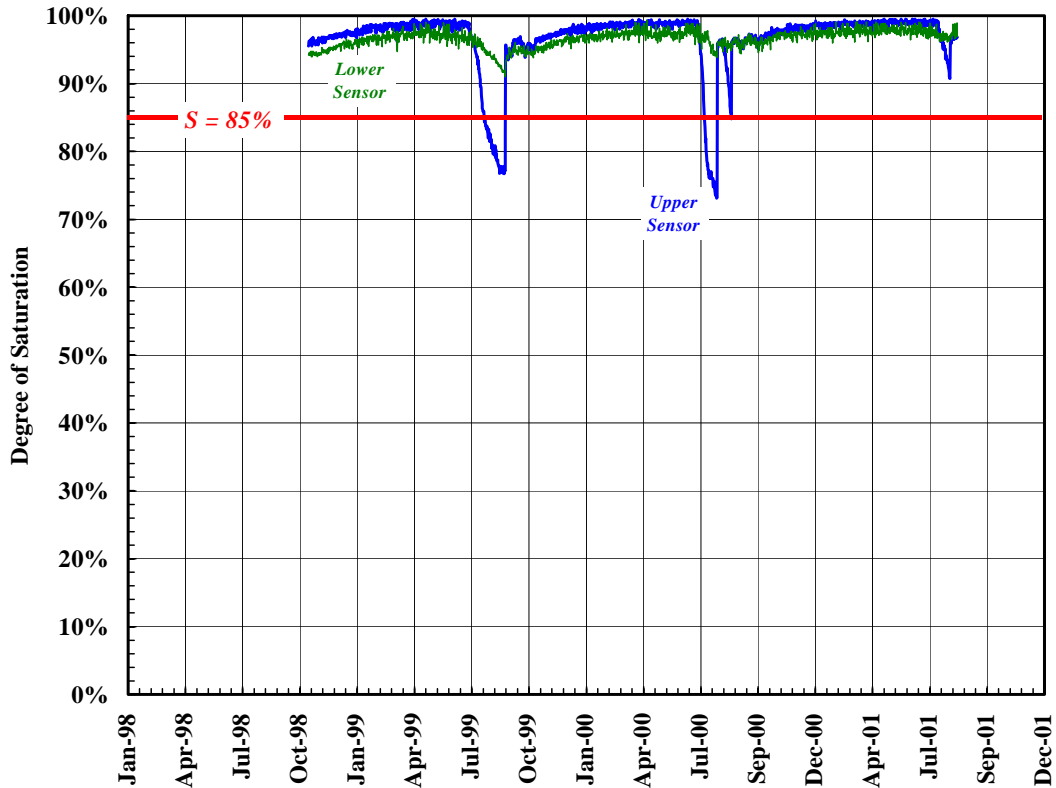
**Figure 1.8** Degree of saturation of the upper and lower sensors installed in the compacted till-bentonite layer at TP-4 for Myra Falls.

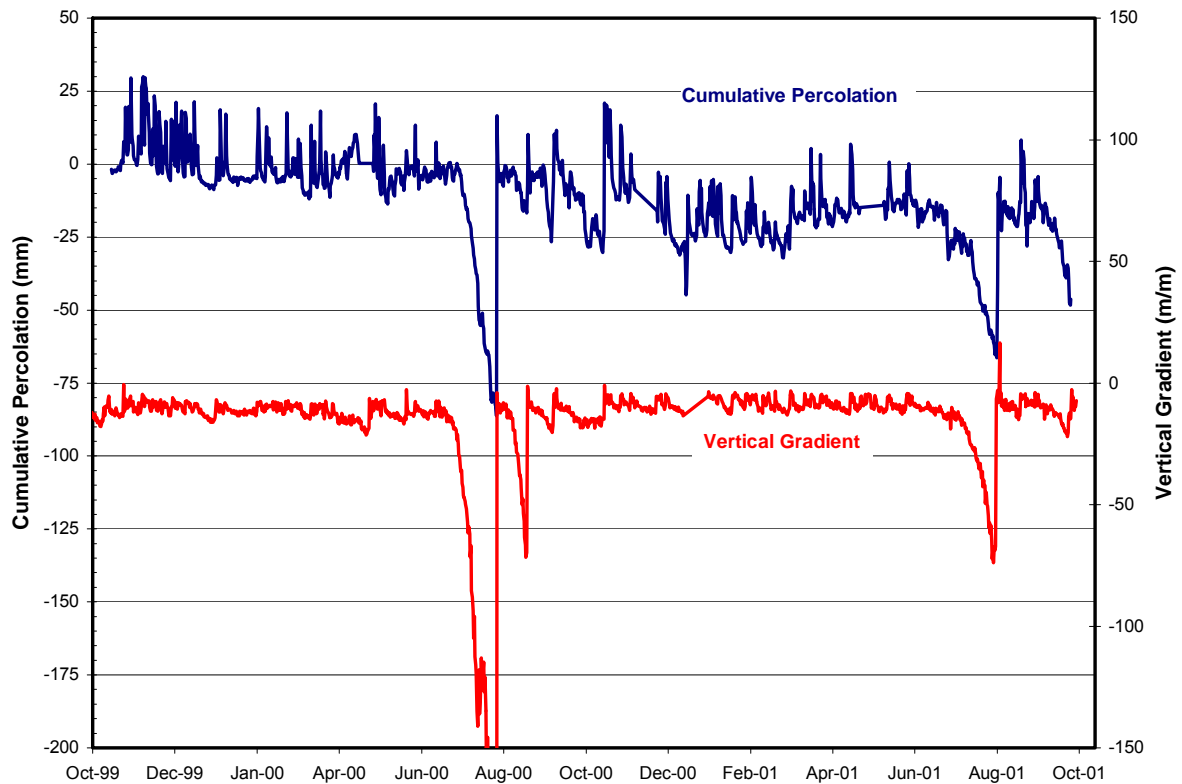
The vertical gradient between the 0.75 m and 0.85 suction sensors in the upper suction sensor nest of TP-3 is shown in Figure 1.9, together with the cumulative net percolation. A positive gradient indicates the potential for downward percolation, whereas a negative gradient implies upward flow. The gradient is negative or upward for the majority of the year, which is unexpected especially during the fall and spring seasons. This could be due to the low *in situ* suctions being measured at the cover layer / waste rock interface, and the small distance between the sensors. For example, if one sensor reads 7 kPa suction when the suction condition is actually 5 kPa, then it could lead to inconsistencies in the calculated vertical gradients. The significant trend shown on Figure 1.9 is the strong upward gradient produced in the summer months at TP-3. The conditions suggest that the lysimeter is “drying out” as water is “pulled up” from the lysimeter into the cover layer in response to atmospheric forcing. This response is shown in the pressure transducer readings as an upward net percolation is measured during the summer months in 2000 and 2001.

**Figure 1.9** Cumulative percolation and vertical gradient measured at TP-3 for Myra Falls.

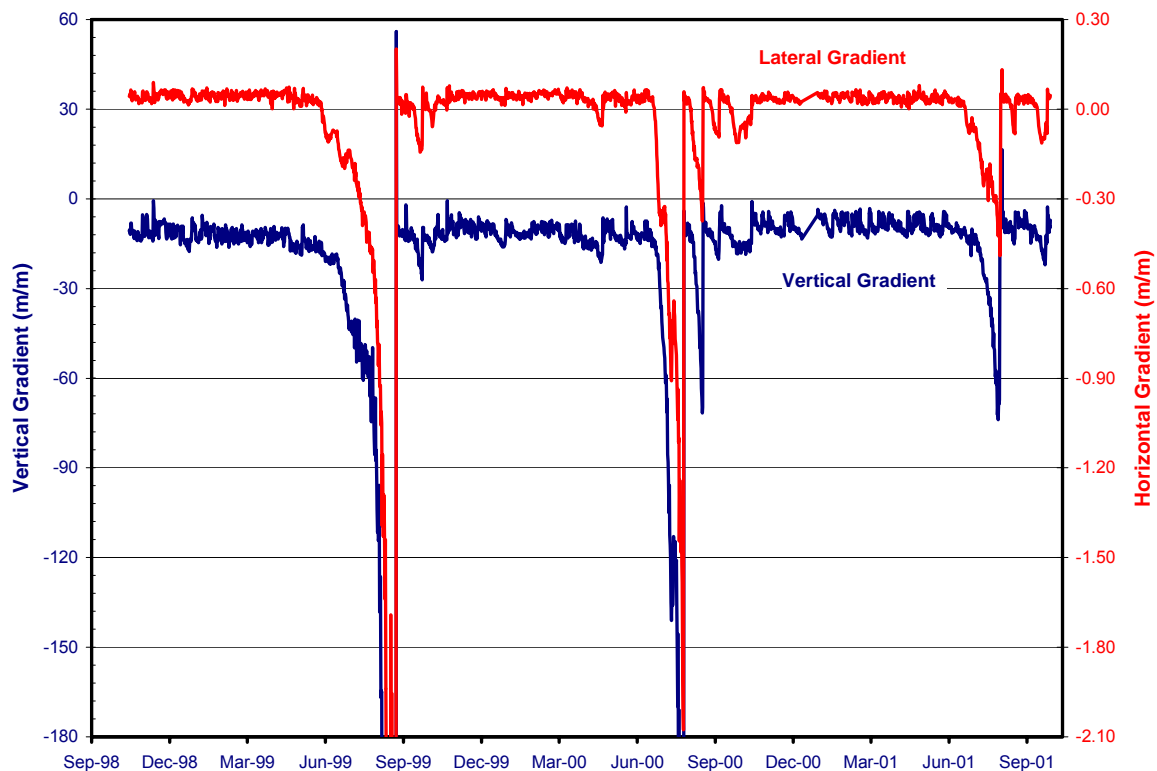
The horizontal gradient defines the direction of lateral flow within the test plot cover layer. A positive gradient indicates a flow from the upper area of the cover layer to the lower area. A high lateral gradient suggests the compacted cover layer is diverting flow from percolating vertically into the underlying waste rock material. Figure 1.10 compares the lateral gradient to the vertical gradient for up-gradient nest of suction sensors. The gradients mimic each other and an up-slope lateral gradient is seen in the summer months when there is a strong upward vertical gradient. However, the lateral gradient is approximately 100 times smaller than the vertical gradient indicating that the lateral gradient has a small influence on flow for the conditions being monitored. It is important to note however, that for longer slope lengths, and in particular for a steeper slope angle than is being monitored, the lateral hydraulic gradient could be significant. Note also that a calibrated model could be developed for the conditions being monitored, and once developed could then be used to model alternate slope lengths and slope angles to evaluate the impact on performance.

**Figure 1.10** Horizontal and vertical hydraulic gradients measured at TP-3 for Myra Falls.

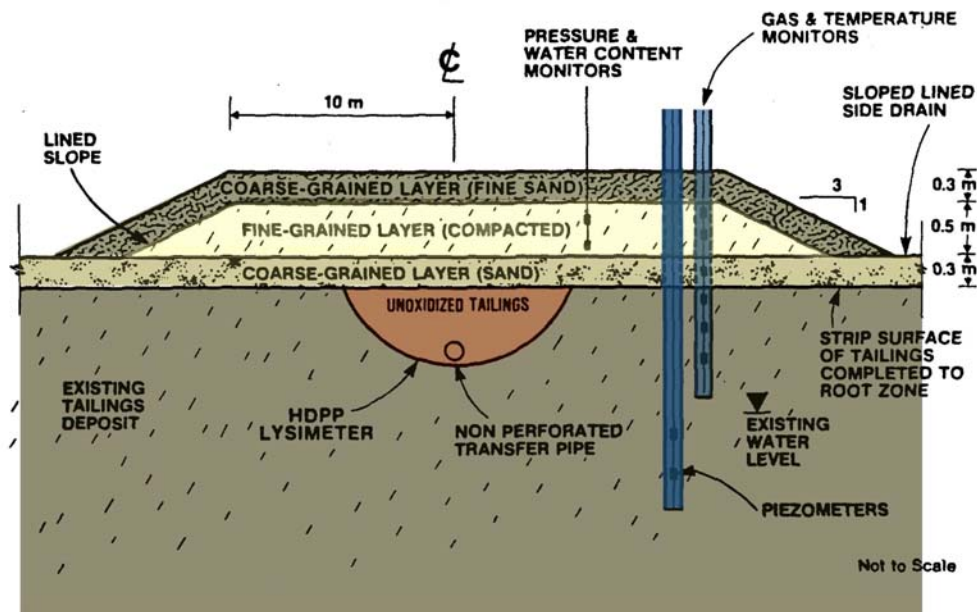
These cover layer depths were selected to provide maximum reduction in oxygen ingress and a sufficient safety factor to minimize the effects of adverse climatic conditions such as freezing and thawing. The design of the cover was based on the results of a laboratory study that concluded the composite cover would be able to resist significant moisture losses during dry climate conditions. The geomembrane cover consisted of an 80 mil (2 mm thick) high-density polyethylene (HDPE) liner material placed between a fine sand and underlying coarse sand layers.

**Figure 2.1** Cross-section through composite soil cover test plot at Waite Amulet tailings (from Yanful and St-Arnaud, 1991).

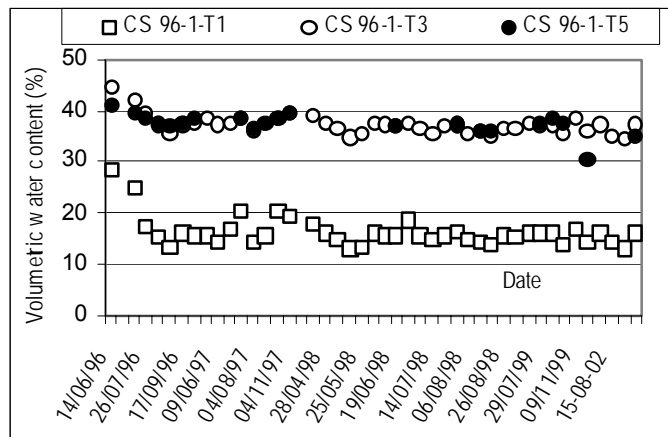
The results of the monitoring on the sloping surfaces of the cover showed that the upper slopes have a tendency to de-saturate during prolonged drying events. However, precipitation events have been shown to quickly recharge the moisture retaining layer on the sloping surfaces. The lower slopes have similar behaviour to the flat surfaces of the full scale cover system.

**Figure 2.3** Moisture content results from the CS 96-1 T1 station showing capillary barrier effects (Bussière *et al.*, 2003).

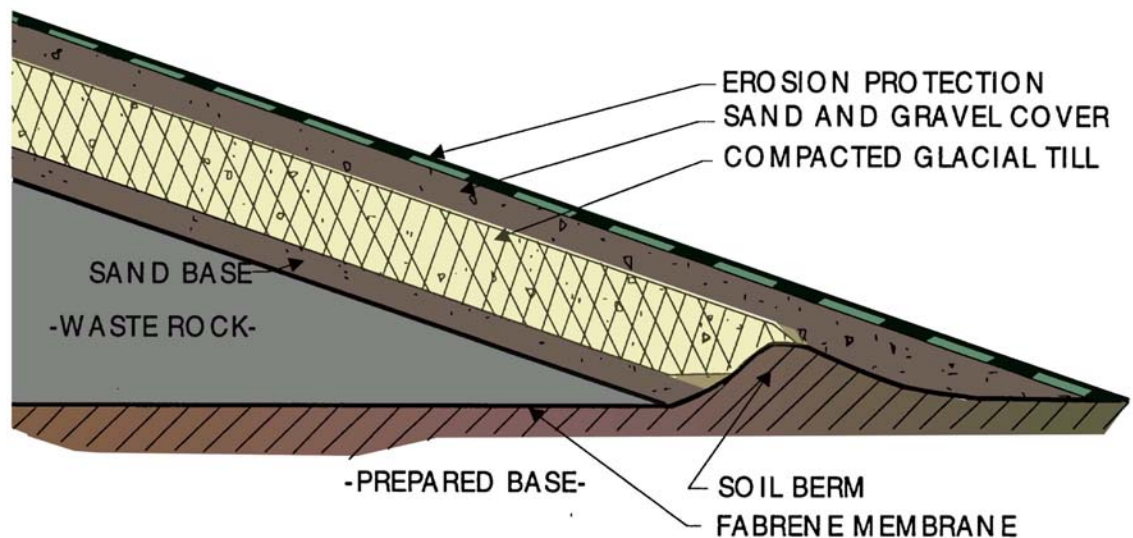
A cover system with these specifications was constructed in late summer of 1991. Figure 3.1 shows the construction details of the soil cover system used on Pile 7/12.

**Figure 3.1** Soil cover construction details at Heath Steele (from Yanful *et al.*, 1993c).

- a 30 cm base granular layer;
- a 60 cm saturated glacial till layer;
- a 30 cm overlying coarse grained granular layer; and
- a 10 cm erosion protection layer.

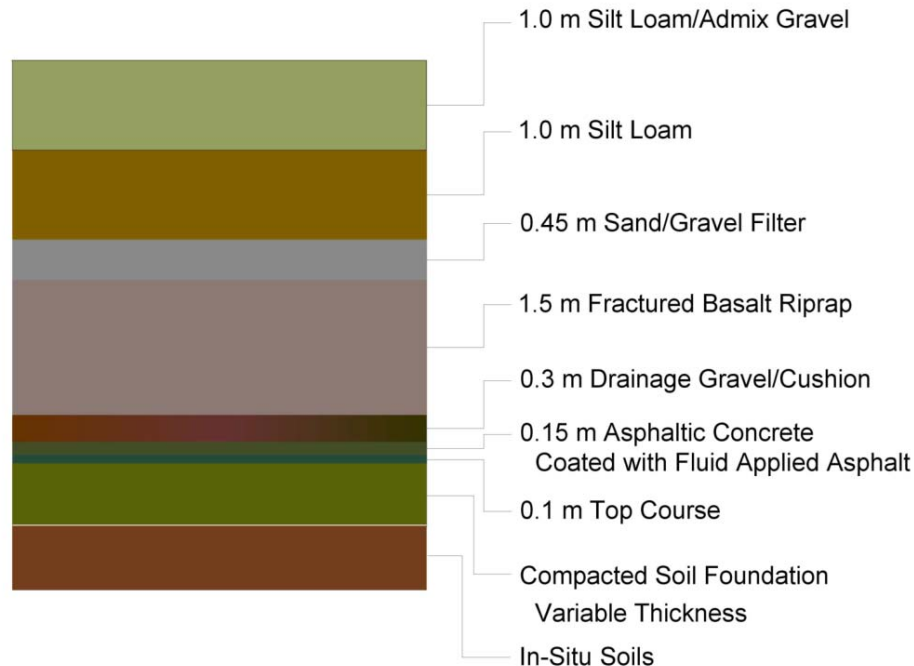
(e.g., sand, gravel, and riprap) below the fine soil layer provide a capillary break that restricts biointrusion. The asphalt concrete layer below the coarse materials is designed to divert any water that percolates through the capillary barrier.

**Figure 3.2** Cover system used at Hanford site (from MEND 2.21.3a).

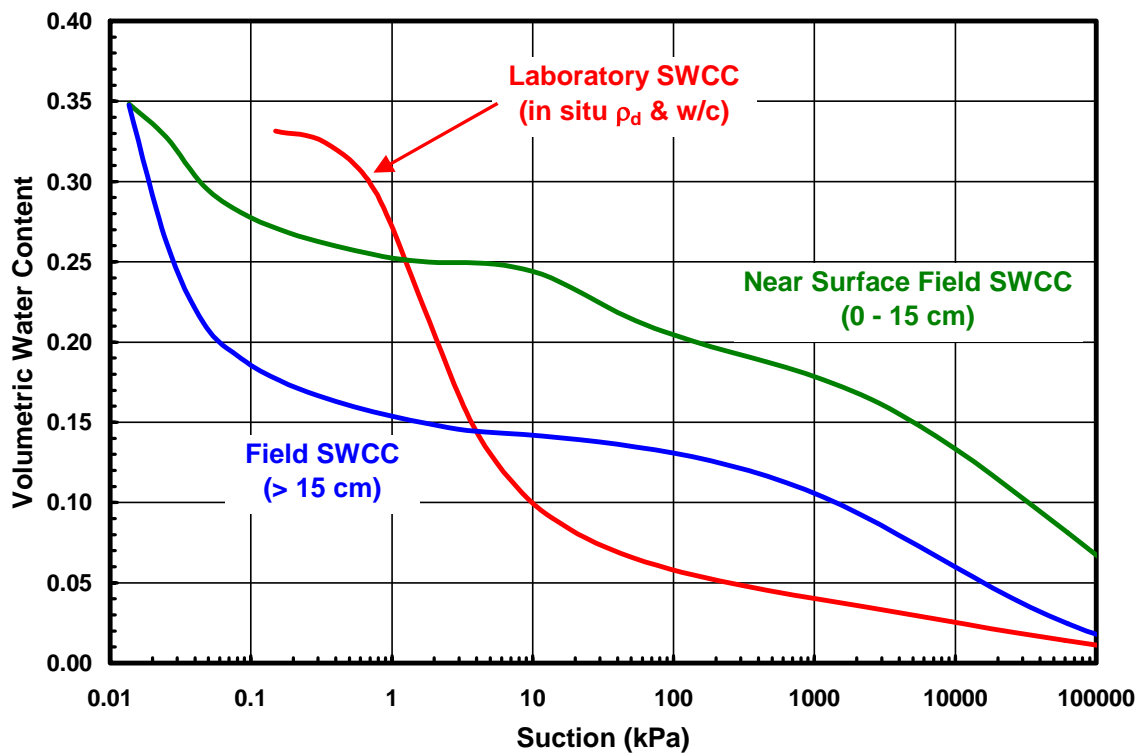
The SWCC and the hydraulic conductivity functions are the most important functions in a soil-atmosphere numerical model. Figure 4.1 compares the *in situ* SWCC measured in the field at the W22 OSA (Test Plot 1) to the SWCC measured in the laboratory prior to construction of the test plots. The field SWCCs show a “double hump”, or are bi-modal, which is typical of field SWCCs. The bi-modal SWCC is indicative of a gap-graded material in which the coarse materials de-saturate first at a low suction value producing the function's first steep downward slope. The second hump is produced when the finer-textured materials start to de-saturate. This point is rarely well defined in field measurements due to the inherent heterogeneity of the cover materials. Figure 4.1 shows that there was a significant difference between the shape of the laboratory and field SWCCs, even though the laboratory test was completed on a sample prepared to *in situ* density and moisture content conditions, which were measured during the potential cover material sample collection phase of the project.

**Figure 4.1** Comparison of the laboratory and *in situ* field SWCCs for the BIF cover material.

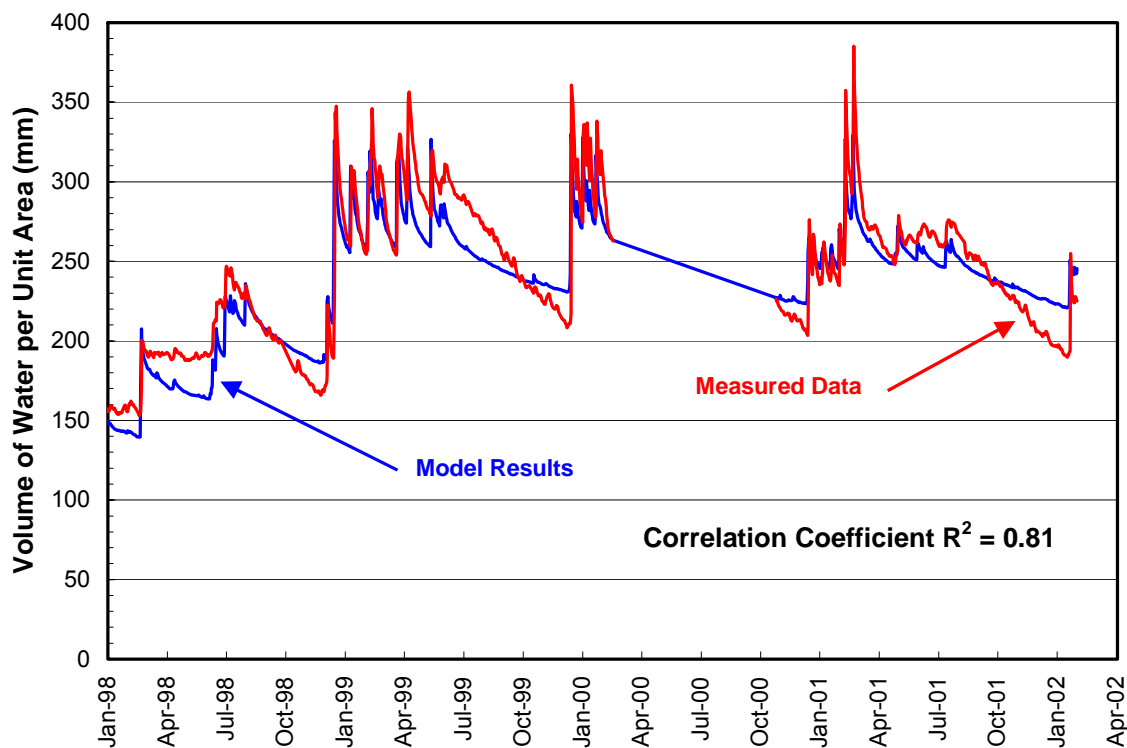
It is important to note that the results shown in Figure 4.2 and discussed above were generated on the first attempt of the numerical simulation with minimal changes to the numerical model. The field SWCCs were input to the model as well as estimated hydraulic conductivity functions based on the field SWCCs and field saturated hydraulic conductivity testing. Very few of the model inputs were “tweaked” or varied in successive model runs to better fit the data. This exercise showed the value of field-based material properties such as the SWCC and the value of accurate, detailed performance monitoring systems, which are used to generate the field SWCC.

**Figure 4.2** Comparison of the calibrated numerical model results to actual measured field data covering the period from January 1998 to February 2002.

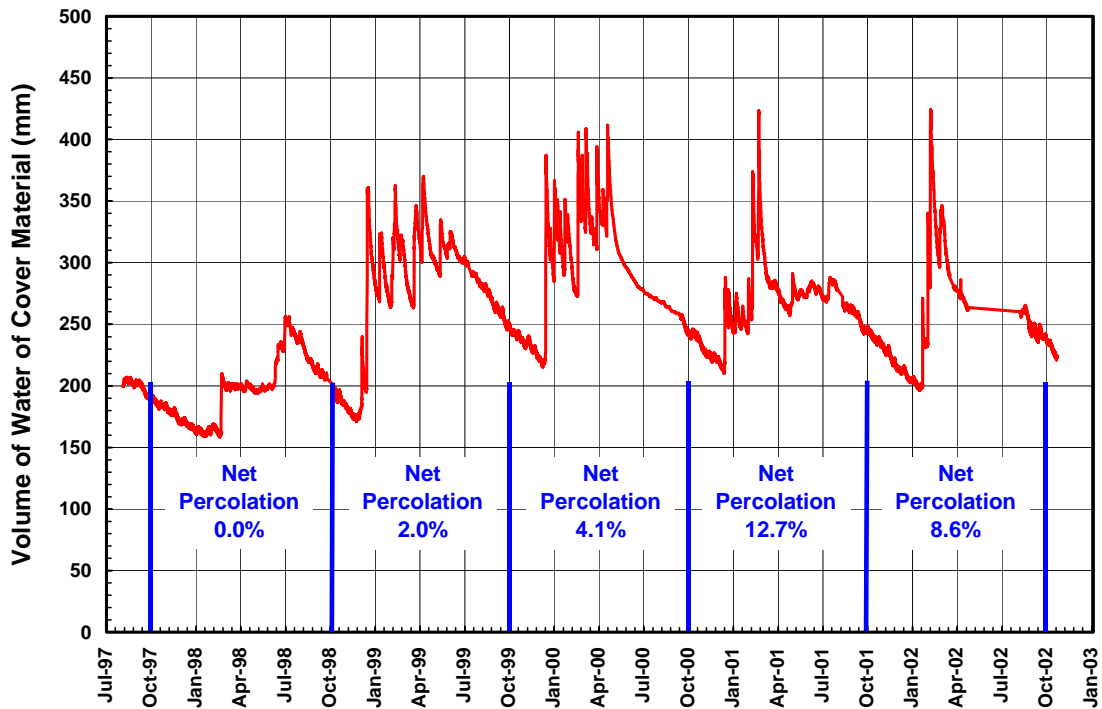
The annual rainfall for the first year of monitoring (October 1997 to September 1998) at Test Plot 1 was 295 mm. No net percolation was recorded during this monitoring period. Rainfall was significantly higher in the next three years with 870 mm recorded in 1998-99, 1,160 mm in 1999-2000, and 497 mm in 2000-01. Net percolation through the cover system was recorded because the storage capacity of the cover system was exceeded by the successive wet years. Figure 4.3 shows the calculated volume of water within the cover system, as well as the net percolation recorded in each year, expressed as a percentage of annual rainfall.

**Figure 4.3** Net percolation and change in cover material storage at Test Plot 1.

Net percolation was greatest in 2000-01 when net percolation was approximately 13% of the annual rainfall. This is a significant amount of net percolation compared to the negligible net percolation predicted by the numerical model. The high net percolation in 2000-01 was likely due to the high rainfall in 1999-2000; as there is a lag time required for the infiltrating water to penetrate to the base of the cover system and further to the base of the lysimeter used to monitor net percolation. It is more appropriate to view net percolation over an extended time period to reduce the lag effects and develop an average net percolation value. The net percolation for the time period shown on Figure 4.3 was 5.0% of the rainfall recorded.

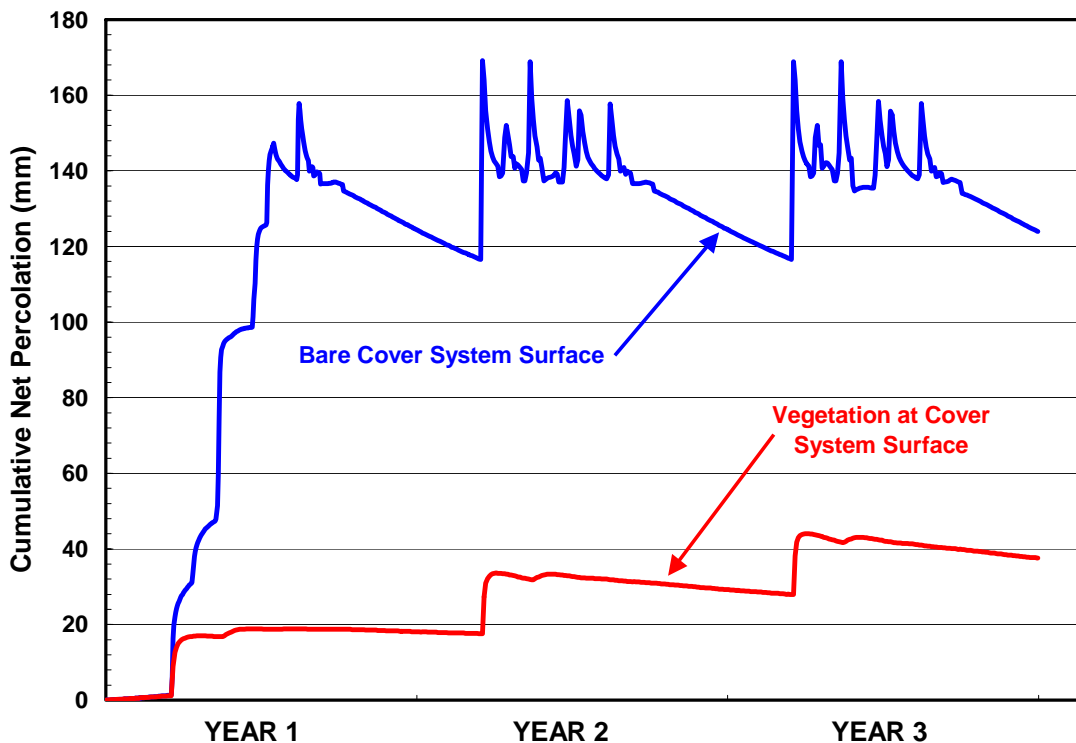
The cumulative net percolation for the bare cover system simulations was 125 mm or 4.8% of the cumulative rainfall for the period. This percolation rate is similar to the 5.0% measured value at Test Plot 1. The net percolation predicted for a vegetated surface was 37 mm, or approximately 1.4% of the cumulative rainfall.

**Figure 4.4** Net percolation predicted for consecutive wet year simulations.

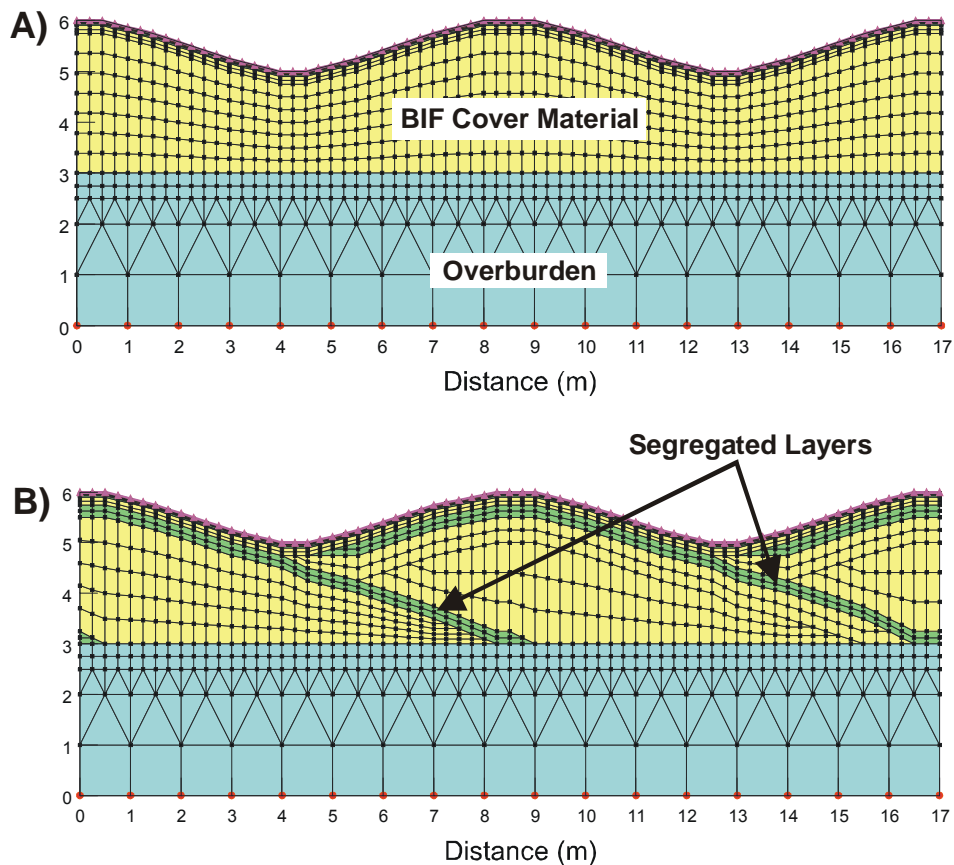
**Figure 4.5** a) Mesh used in the 2-D analysis of the Mt. Whaleback hummocky cover system.  
b) Coarse-textured segregation layers added to the 2-D mesh.

The results of the simulations are summarized in Figure 4.6. Minimal net percolation was predicted for the hummocky cover system with no segregation layers. Net percolation was highest (between 5 to 6 mm) below the depressions on the undulating surface. Surface runoff collected in these depressions during the high intensity rainfall events of the simulated climate year driving water into the cover system and resulting in the higher net percolation values. The average net percolation for the cover system was minimal. The cover system with segregation layers showed high net percolation in the two areas where the segregated layer connected with the surface of the overburden. Net percolation was approximately 180 mm in these areas, significantly increasing the average net percolation across the entire cover system modelled (i.e. the mesh shown in Figure 4.5).

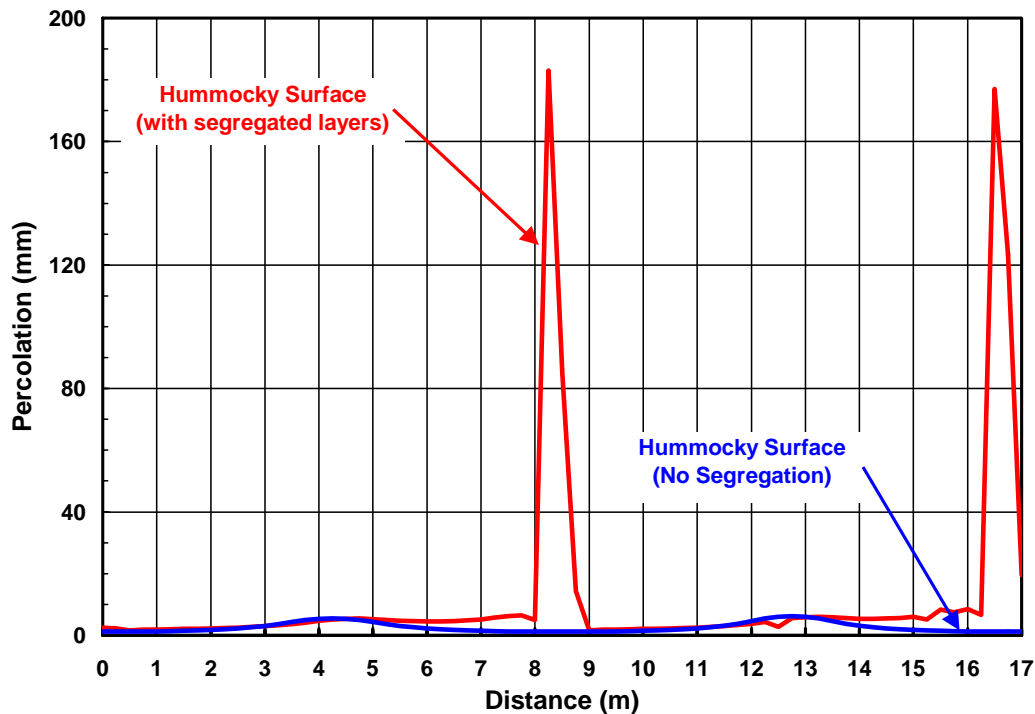
**Figure 4.6** Net percolation results predicted for the homogeneous and segregated cover systems.

The segregation layer produces a preferential, or macro-pore, flow path for meteoric waters to infiltrate to the underlying overburden material during extreme climate events. Macro-pore flow occurs in these areas resulting in high hydraulic conductivity rates causing rapid percolation to the underlying overburden material. The effects of segregation have also been observed at Test Plot 2. Volumetric water content sensors will show quick responses to rainfall events at depths up to two or three metres, suggesting high hydraulic conductivity flow paths exist within the test plot. Note however that these flow paths only become “active” during the extreme rainfall events or when surface runoff promotes accumulated surface flow to the area of segregation. Once the meteoric waters percolate to depth, it is an extremely slow process to “pull” the moisture back to the surface because flow occurs in the matrix of the cover material. In addition, if rainfall events occur prior to exfiltration of the moisture to the surface (or transpiration of the moisture), then unsaturated “piston” flow will “push” the moisture deeper into the profile, and potentially to a depth where moisture cannot be removed as evapotranspiration. Segregation has an adverse effect on moisture store-and-release cover systems because the macro-pore flow paths allow infiltration of moisture deep into the cover profile during the wet season where it might not be removed before the start of the next wet season. This can result in the deeper moisture reporting as net percolation.

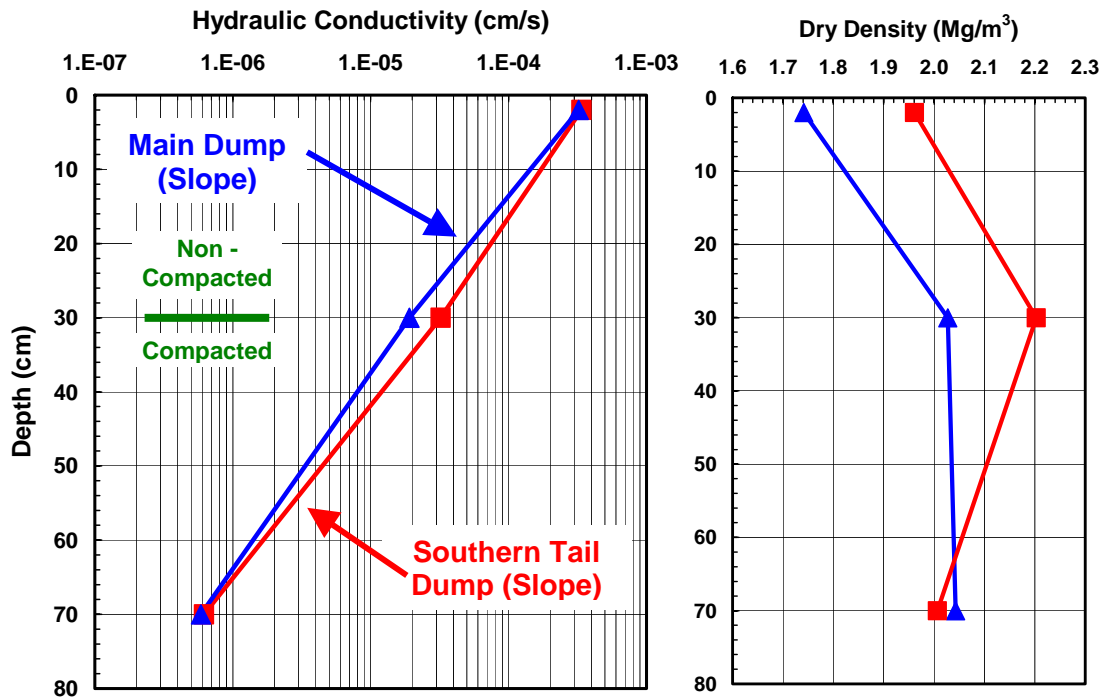
Based on the relationship between density and hydraulic conductivity, it was anticipated that values of  $K_{fs}$  measured at 30 cm would be as low or lower than those at 70 cm due to the higher *in situ* density. However, values of  $K_{fs}$  at 30 cm were two orders of magnitude greater than at 70 cm. It would seem likely that the increase in hydraulic conductivity is a result of a change in soil structure. Two possible physical processes that could lead to a change in structure at the site are freeze-thaw cycling and wet-dry cycling. Temperature sensors installed in the compacted layer indicate that this region of each cover system is not undergoing freeze-thaw cycles at any of the automated monitoring locations.

**Figure 4.7** Saturated hydraulic conductivity and density measured for the sloping cover systems at Equity Silver.

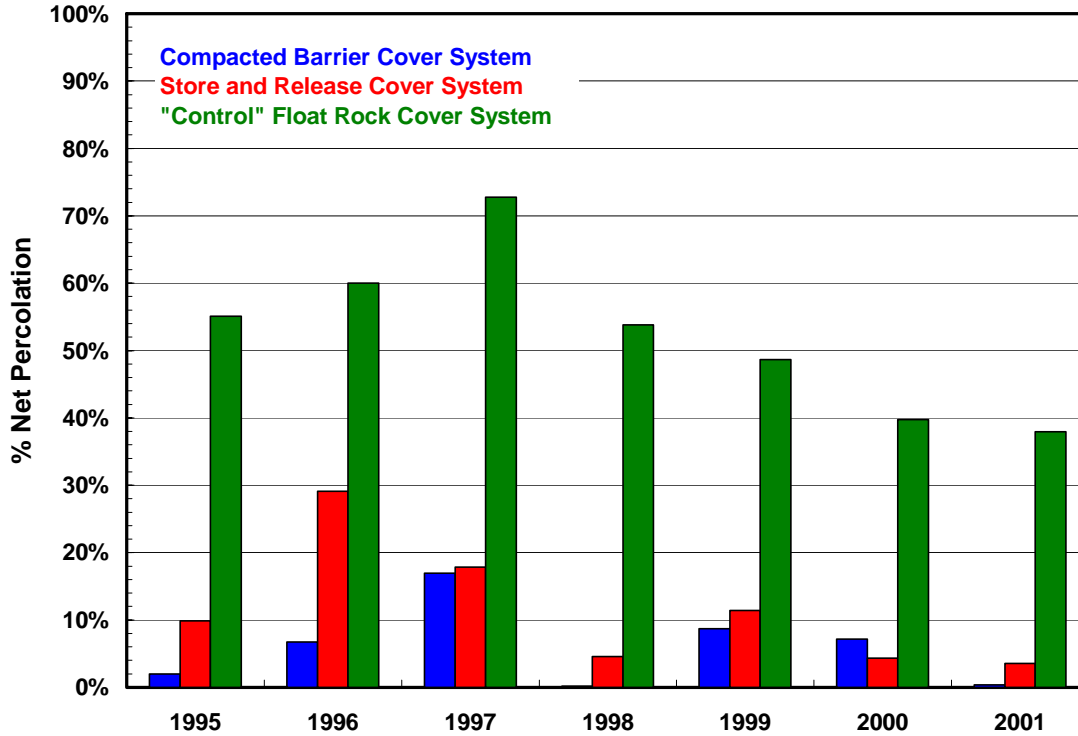
period, which is slightly less than the 8.8% average net percolation recorded at the moisture store-and-release cover system. The performance of the “control” float rock cover system was distinctly higher; on average the control plot allowed 52% of the annual precipitation through as net percolation.

**Figure 4.8** Comparison of the performance of the cover system test plots at Kimberly Operations (1995-2001).
