**DESIGN, CONSTRUCTION AND  
PERFORMANCE MONITORING OF  
COVER SYSTEMS FOR WASTE ROCK  
AND TAILINGS**

**VOLUME 5 – CASE STUDIES**

**MEND 2.21.4e**

OKC Report No. 702-01

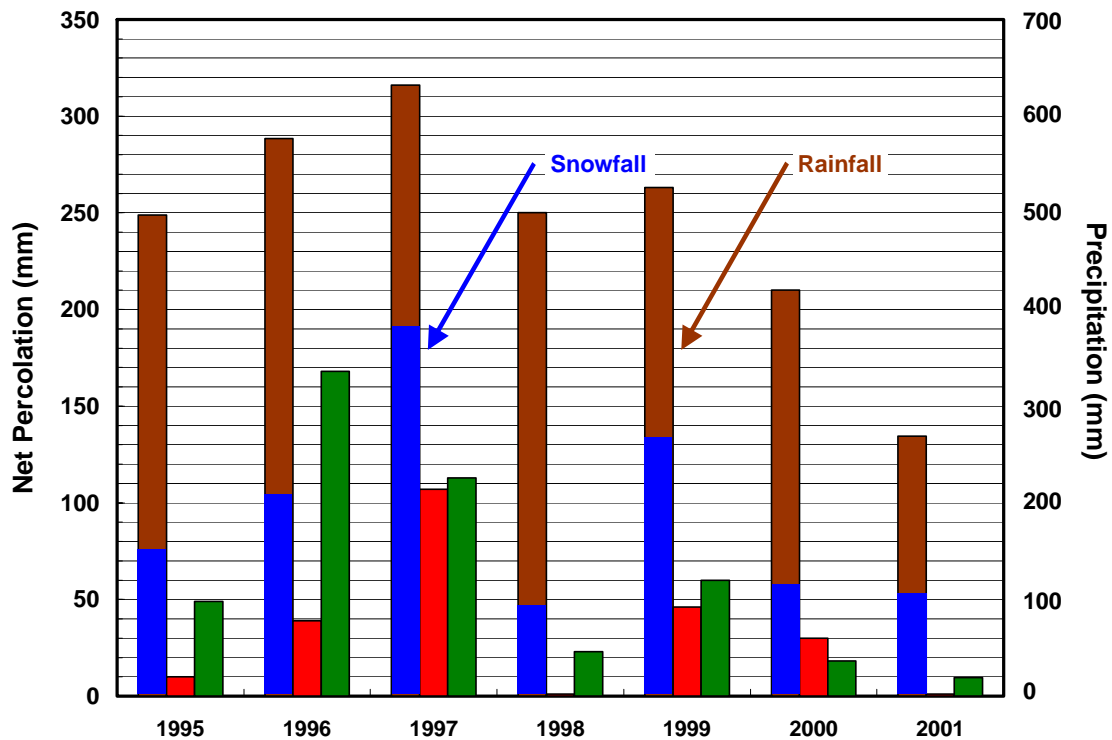
precipitation and snowfall for the two years. The highest total precipitation and snowfall was recorded in 1997, which led to the highest net percolations measured during the monitoring period, if the results for the two test plots are averaged. A significant increase in net percolation was recorded for the compacted barrier cover system while net percolation through the moisture store-and-release cover system decreased. Minimal net percolation was measured at the test plots in 1998; this year had the lowest snowfall measured during the monitoring period. In the following year, snowfall and total precipitation increased leading to above average net percolation measured at the test plots. Finally, the net percolation recorded in 2000 and 2001 was low, with 2001 recording the lowest net percolation for the monitoring period.

**Figure 4.9** Net percolation and precipitation recorded at the compacted barrier and moisture store-and-release cover systems (1995-2001).

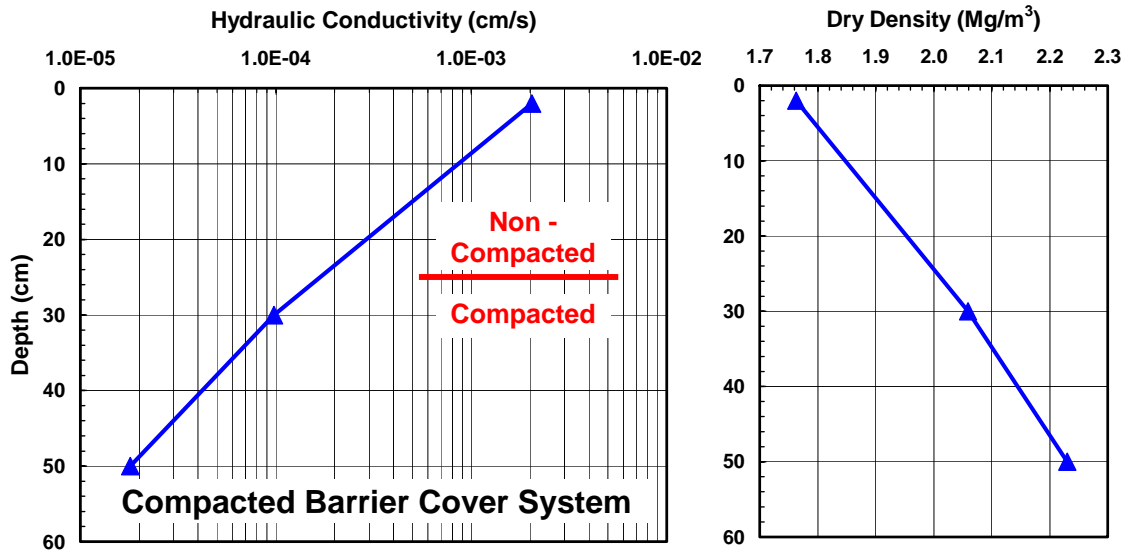
properties of the upper lift of the compacted barrier layer. Possible processes that could lead to a change in structure at the site are freeze-thaw cycling, wet-dry cycling, and the influence of plant roots identified from the performance monitoring data collected at the site. Temperature sensors installed in the compacted layer indicate that this region of the cover system is not undergoing freeze-thaw cycles.

**Figure 4.10** Results of *in situ* saturated hydraulic conductivity tests on the compacted barrier cover system at Kimberley Operation.

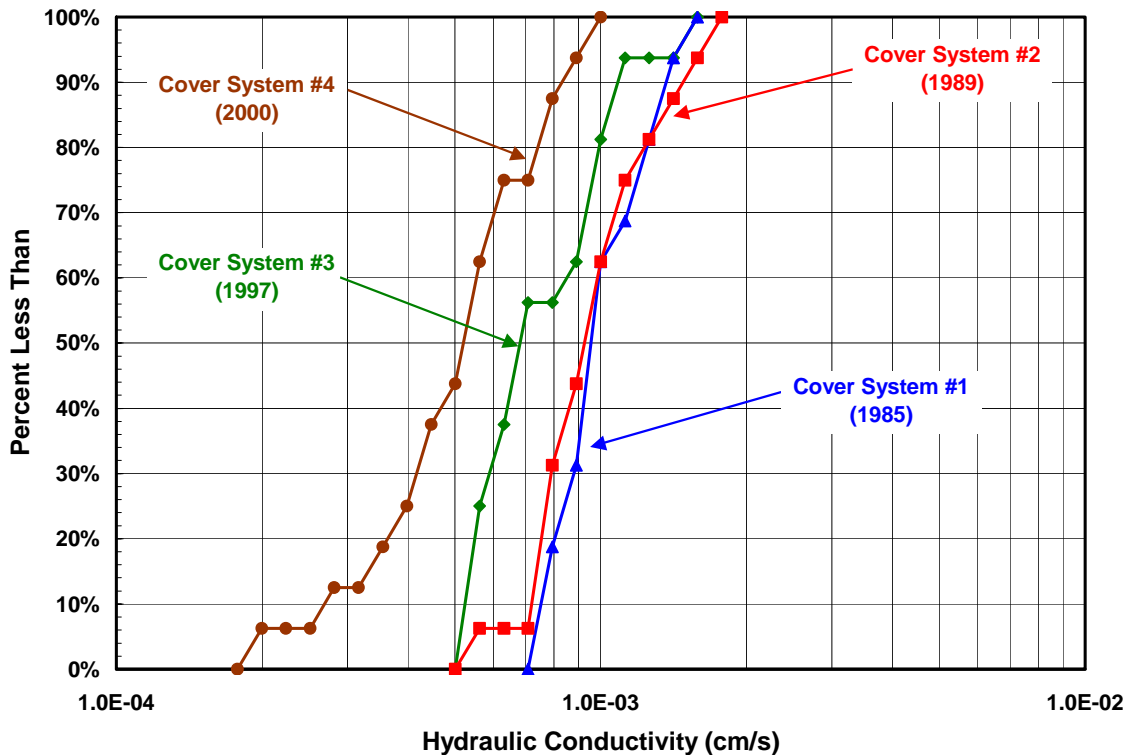
Figure 4.11 is a cumulative histogram of the field saturated hydraulic conductivity values measured with the Guelph permeameter in the summer of 2002. There is a small difference in the field saturated hydraulic conductivity measured at the test plots. If the results of cover systems #3 and #4 are compared, it appears that the finer cover materials are evolving towards the older, coarser cover materials. In the long-term, there may be little difference in behaviour of the cover materials. This is significant because effort was made in the newer cover systems to place a finer-textured material in order to improve cover system performance. The results suggest that in terms of field saturated hydraulic conductivity there will only be marginal difference in the performance of the newer cover systems (constructed with the finer textured material) as compared to the older cover systems (constructed with the coarser textured cover material).

Figure 4.11 Cumulative histogram of the hydraulic conductivity results at the historical site.
